Lisle Community Unit School District 202

Chapter Two: Facility Master Planning

Schiesher Elementary School

Building Tour

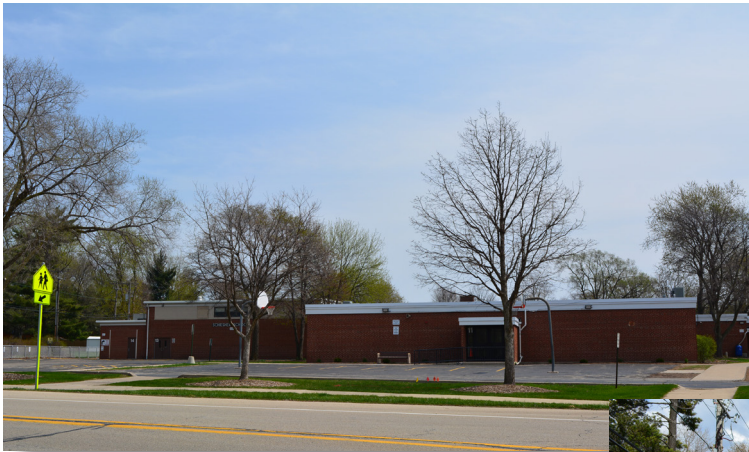
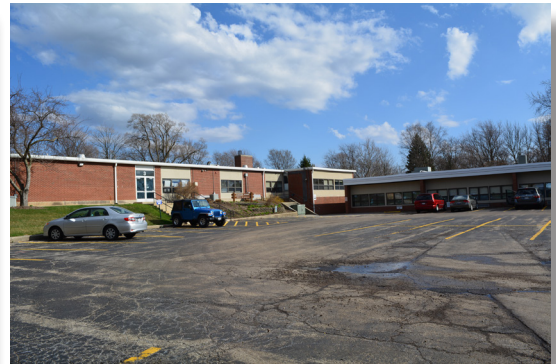
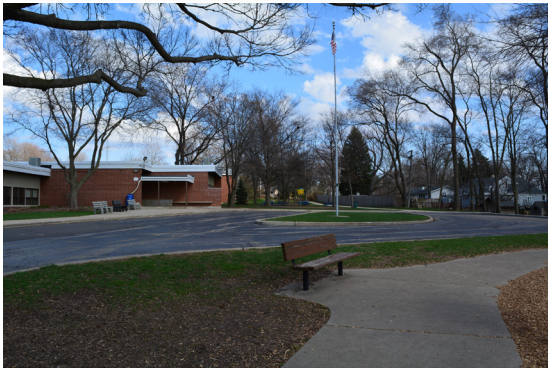
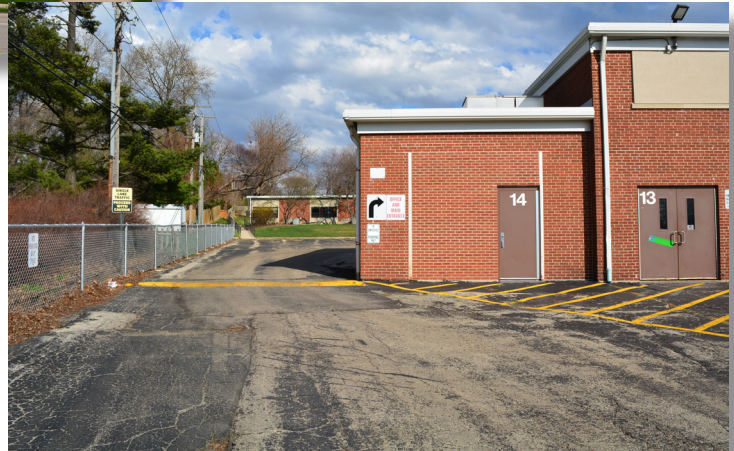
- Updated Playground
- New Sign
- Close to Downtown, JH, HS

- 1 Main entrance is in the rear of the building and not easily accessible for visitors, emergency responders, garbage service, or deliveries
- 2 Parking lots are in need of resurfacing and more parking capacity is needed

- 3 Single lane access/blind spot to back parking lot is a safety concern
- 4 Buses are unable to fit around the circle drive. The tight turn is difficult for buses to negotiate

- 5 Limited parking for visitors, meetings and/or events. Visitor parking located across Kingston Ave. and is limited following snow falls
- 6 Drop-off/pick-up location is located in the visitor parking lot across Kingston. Students must cross the street with the assistance of a crossing guard

- 7 Basketball court location is near Kingston Ave. & doubles as bus parking for Kindergarten bus pick up restricting the use of the paved area
- 8 Playground is located next to the driveway with no physical barrier

- 9 Sight lines are limited due to the different levels of the play fields and playgrounds
- 10 No outdoor storage for recess equipment. Storage shed used to house outdoor maintenance equipment is located in the staff parking lot
